SITE NAME: CHLORIDE AUTOMOTIVE BATTERIES SATELITE SOURCE: H

SITE INVESTIGATION REPORT
CHLORIDE AUTOMOTIVE BATTERIES
COLUMBUS, GEORGIA
GAD991274929

Charles Stephen Walker
Environmental Specialist
Environmental Protection Division
August 1985

SITE INVESTIGATION REPORT

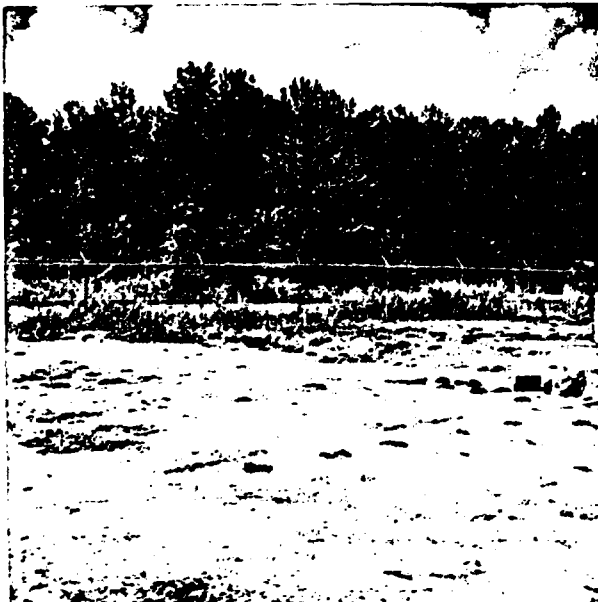
#2 24-JUL-84 WP-1
CHLORIDE

County Name MUSCOGEE
 Picture No 2 of 2
 Site Name CHLORIDE METALS
 Date 24-JUL-84 Weather clear
 Direction Facing SW
 Photographer T. WESTBROOK
 Program 3012
 Explanation: PHOTO OF 3
COMPLETED HOLES FOR WASTE
PILE COMPOSITE
 Other: SAMPLE: WP-1 Chloride
Columbus

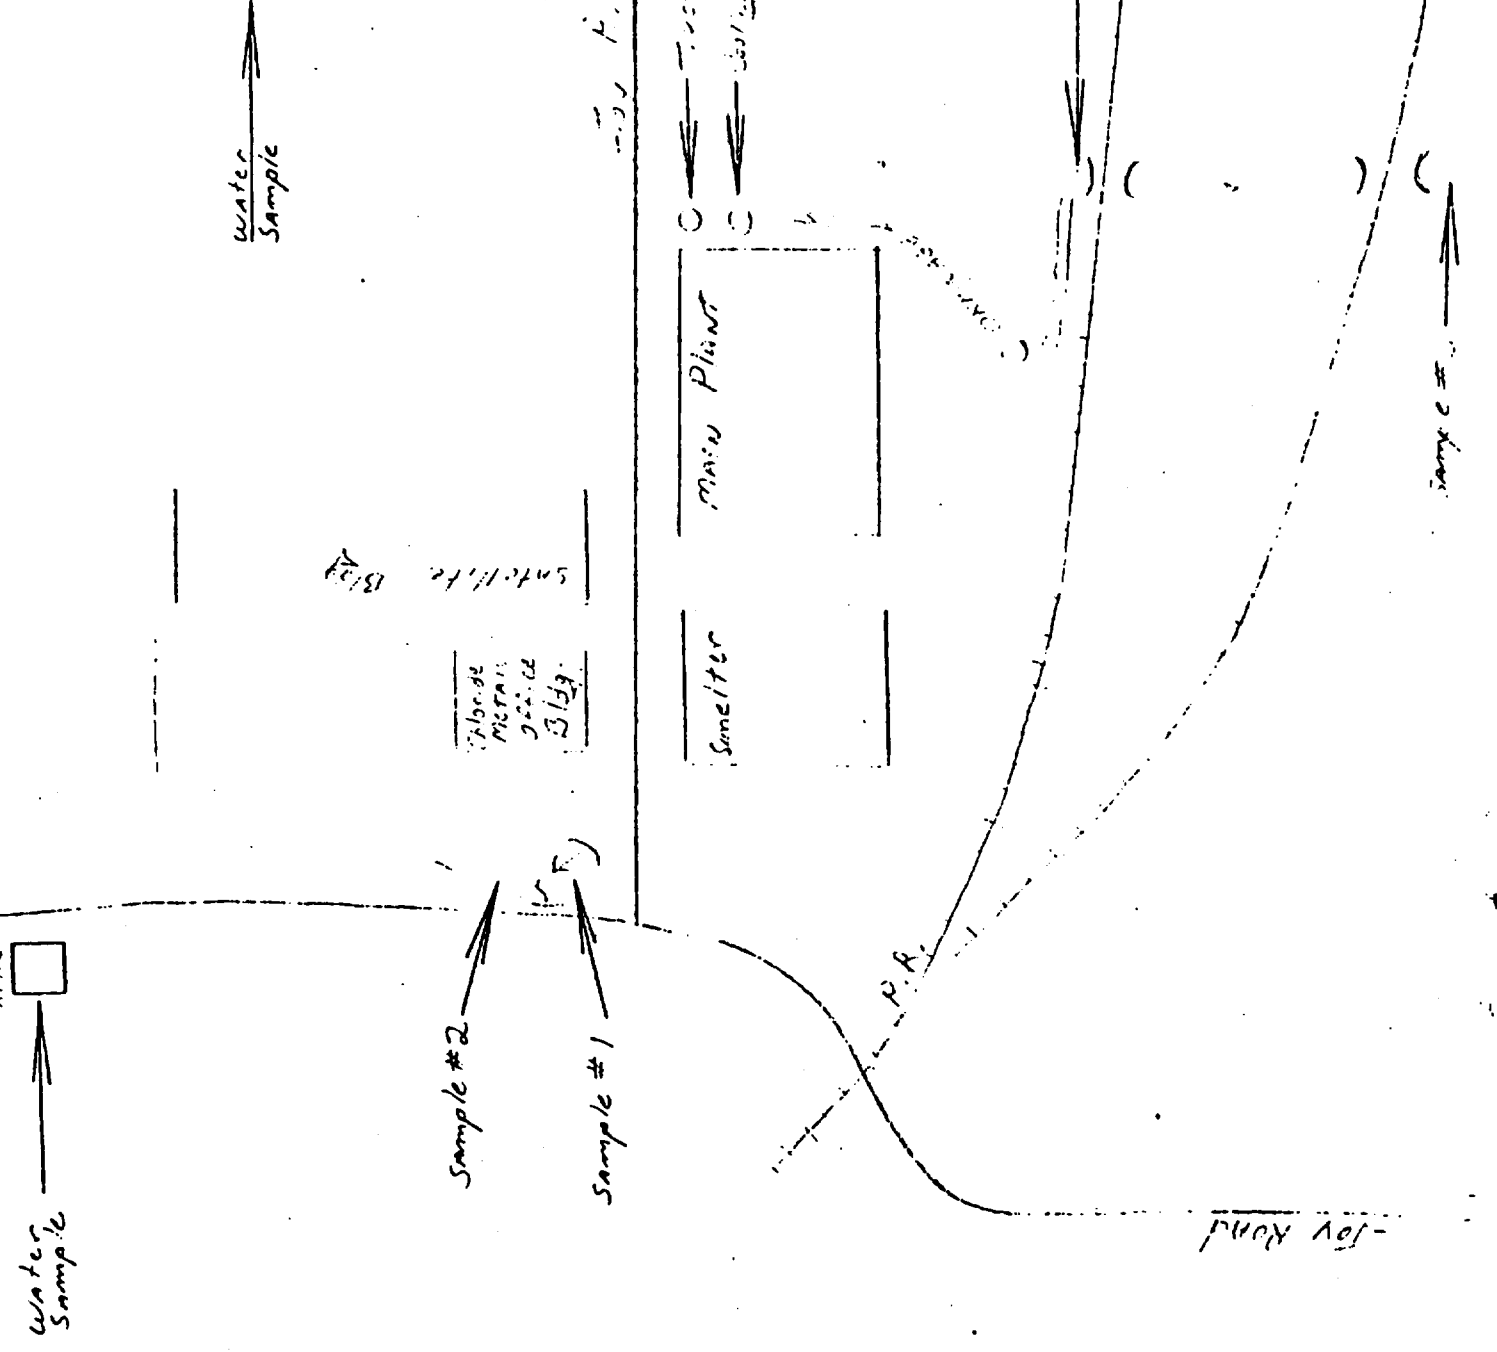
Chloride, Inc.
5-13-92 Sample 6.5
Map #1

On June 10, 1982, Alan Hallum and I met with officials of Chloride Incorporated in Columbus, Georgia to investigate possible sources of contamination into streams surrounding this plant. This investigation was conducted as a result of significant amounts of lead being found in streams and sediment samples collected in the surrounding streams on May 13, 1982.

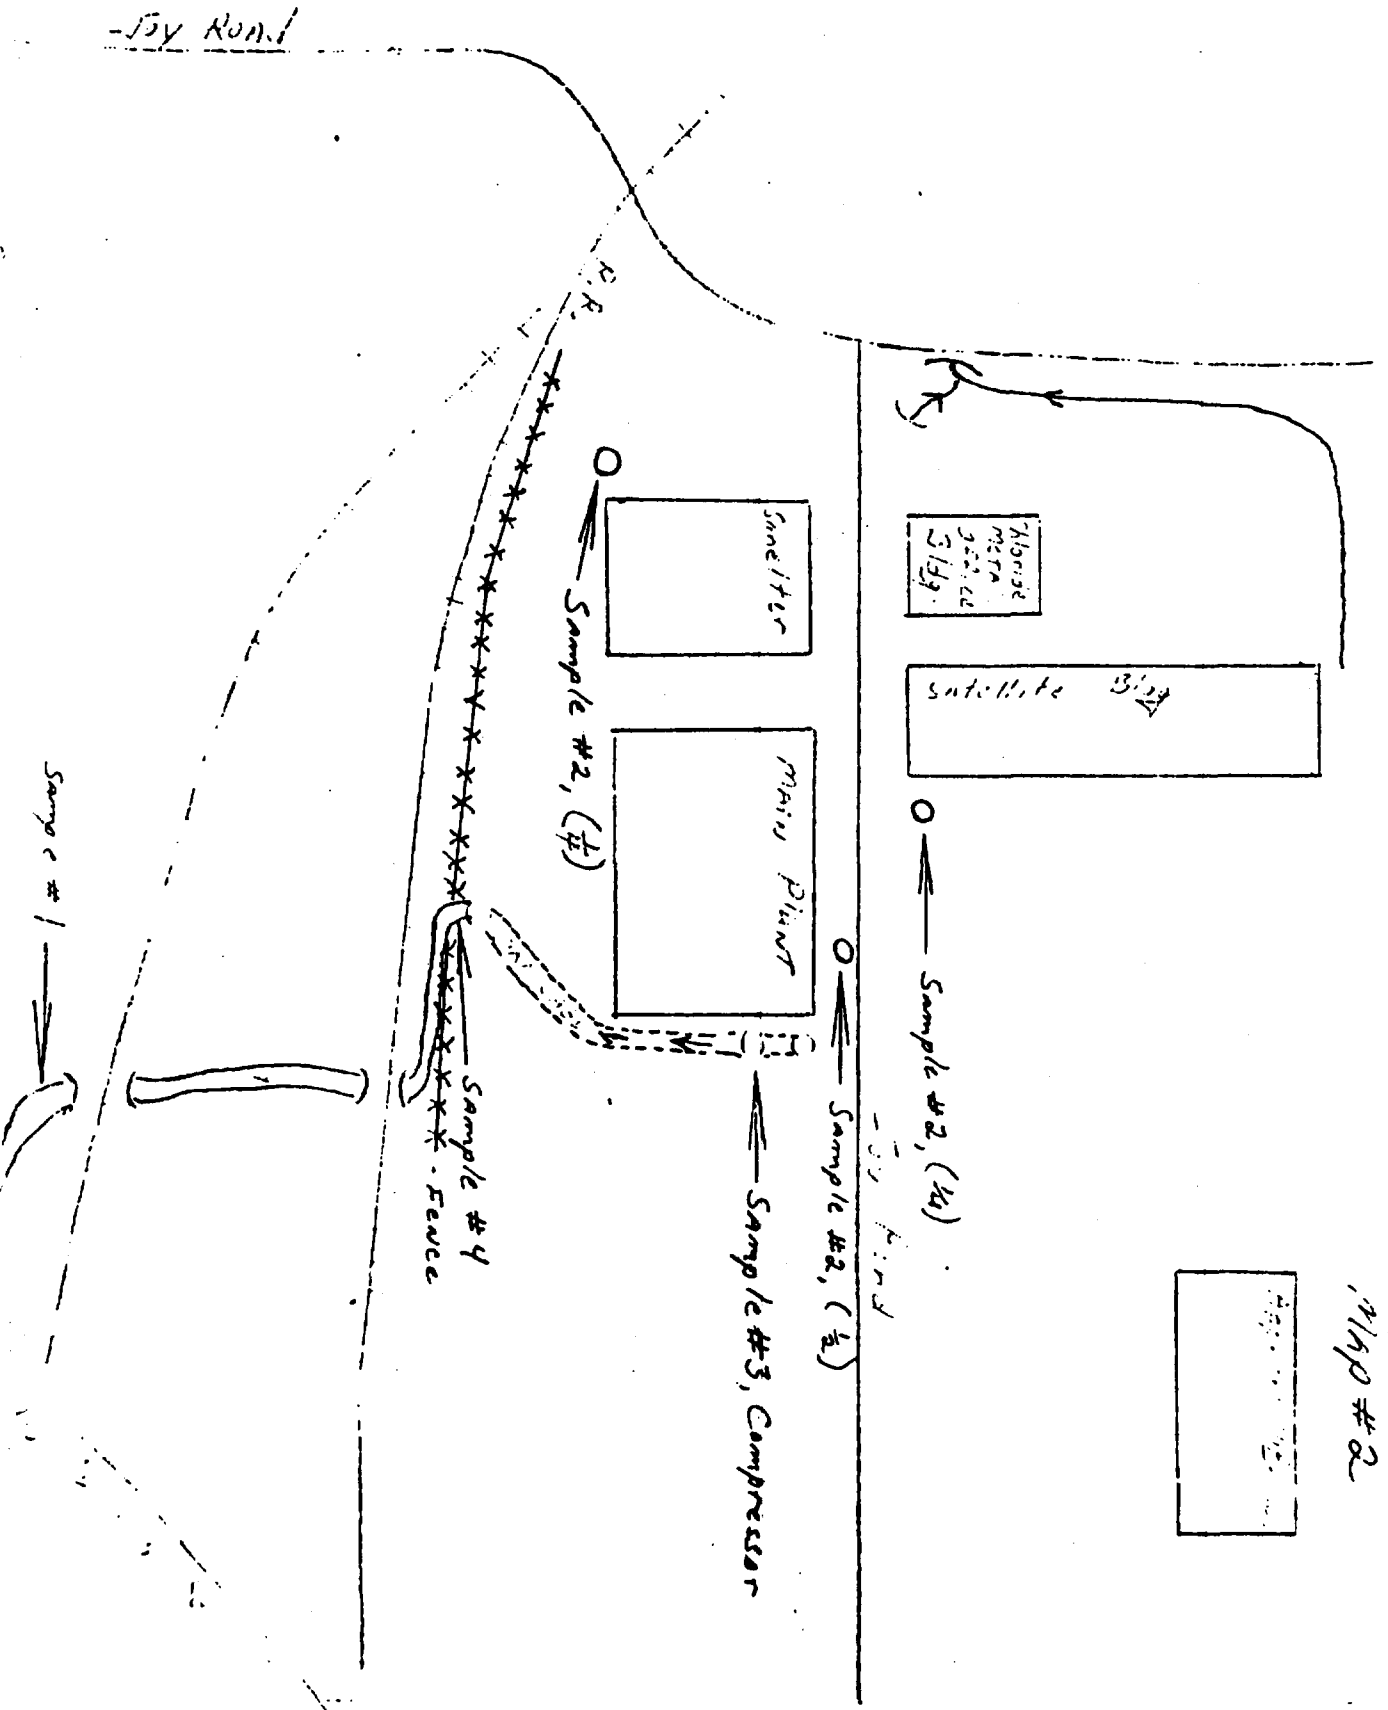
Alonide Inc.
6-10-82
Map #2

**Refer to Map #2
Sample #1	6-10-82 3:45 pm	< 50 ug/l	60 ug/l	10,500 ug/l	< 50 ug/l	110 ug/l	Stream at Cusseta Road (Same location as sample #3 collected 5-13-82)
Sample #1 Sediment	6-10-82 3:45pm	< 5 mg/kg	< 5 mg/kg	740 mg/kg	< 5 mg/kg	16 mg/kg	Same as above. (77.4% Solids)
Sample #2	6-10-82 4:00 pm	3,350 ug/l	705 ug/l	32,000 ug/l	225 ug/l	4,000 ug/l	Discharge to sewer system. One-half of sample is from the Main Plant. One-fourth of sample from the Smelter. One-fourth of sample taken from the Satellite Plant
Sample #3 Sediment	6-10-82 4:10 pm	< 5 mg/kg	50 mg/kg	8,300 mg/kg	< 5 mg/kg	195 mg/kg	Compressor at the Main Plant (65.6% Solids)
Sample #4	6-10-82 4:20 pm	< 50 ug/l	< 50 ug/l	32,000 ug/l	< 50 ug/l	140 ug/l	Discharge to stream inside plant property
Sample #4 Sediment	6-10-82 4:20 pm	6.3 mg/kg	25 mg/kg	46,000 mg/kg	< 5 mg/kg	565 mg/kg	Same as above. (71.2% Solids)
